SUMMARY OF HABITAT ENHANCEMENTS AND BEST MANAGEMENT PRACTISE

Dick Murphy Park, Campbell River Green Shores & Other BMP's

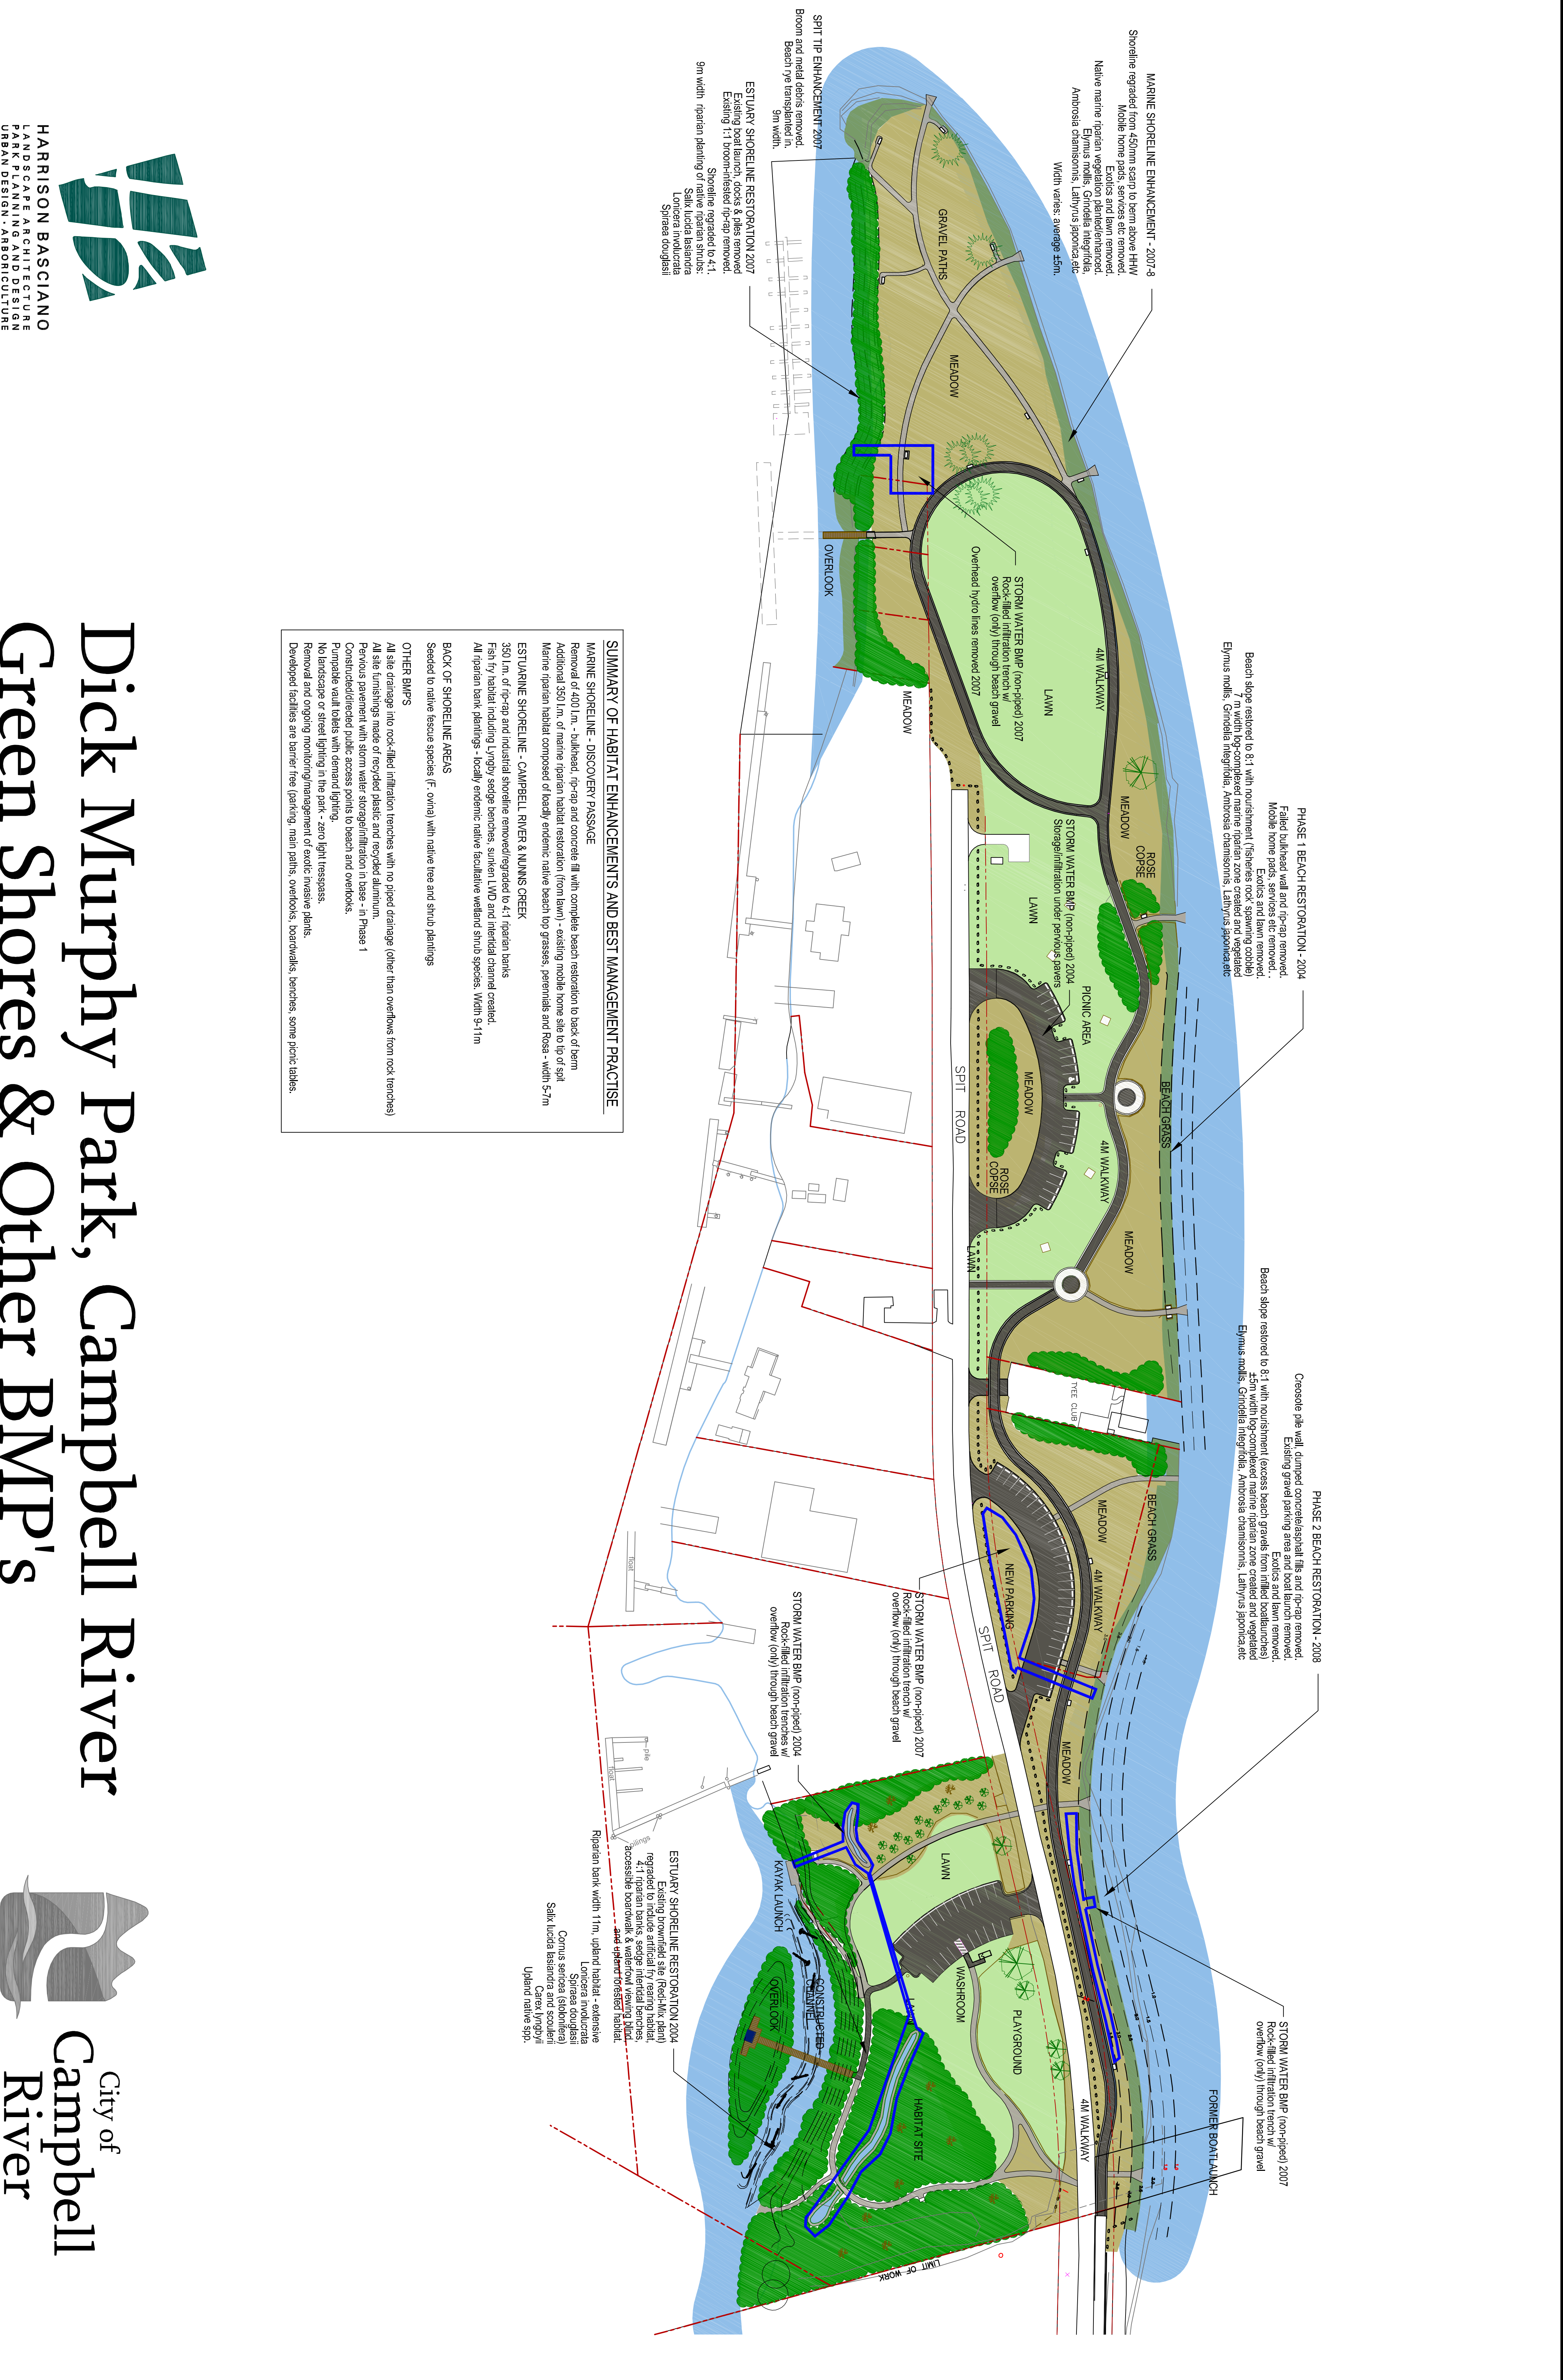
PHASE 1 BEACH RESTORATION - 2004
 Failed bulkhead wall and rip-rap removed. Mobile home pads, services etc removed. Exotics and lawn removed. Beach slope restored to 8:1 with nourishment (fisheries rock, spawning rubble) and rip-rap. Nourishment species: Elymus mollis, Grindelia integrifolia, Ambrosia chamissonis, Lathyrus japonica etc

PHASE 2 BEACH RESTORATION - 2008
 Concrete pile wall, dumped concrete/sand fill and rip-rap removed. Existing gravel parking area and boat launch removed. Exotics and lawn removed. Beach slope restored to 8:1 with nourishment (exotic beach grade) and rip-rap. Nourishment species: Elymus mollis, Grindelia integrifolia, Ambrosia chamissonis, Lathyrus japonica etc

MARINE SHORELINE ENHANCEMENT - 2007 & 2008
 Shoreline regraded from 450mm silt to berm above HHW. Rip-rap and gravel placed in 10m wide zone. Native marine riparian vegetation planted/enhanced: Elymus mollis, Grindelia integrifolia, Ambrosia chamissonis, Lathyrus japonica etc. Width varies, average 45m.

SPIT TIP ENHANCEMENT 2007
 Boom and metal debris removed. Beach re-transplanted in 9m width.

ESTUARY SHORELINE RESTORATION 2007
 Existing boat launch, docks & piles removed. Existing 1:1 boom-nestled rip-rap removed. Shoreline regraded to 4:1. 9m width riparian planting of native riparian shrubs: Salix lucida lasiantha, Lonicera involucrata, Spiraea douglasii

MARINE SHORELINE - DISCOVERY PASSAGE
 Removal of 400' lin. - bulkhead, rip-rap and concrete fill with complete beach restoration to back of berm. Additional 350' lin. of marine riparian habitat restoration (from lawn) - existing mobile home site to tip of spit. Marine riparian habitat composed of locally endemic native beach top grasses, perennials and Rosa - width 5-7m

ESTUARINE SHORELINE - CAMPBELL RIVER & MUMMS CREEK
 350' lin. of rip-rap and industrial shoreline removed/regraded to 4:1 riparian banks. Fish fry habitat including Lyngby sedge benches, sunken LWD and inertial channel created. All riparian bank plantings - locally endemic native facultative wetland shrub species. Width 9-11m

BACK OF SHORELINE AREAS
 Seeded to native rescue species (F. ovina) with native tree and shrub plantings

OTHER BMPs
 All site drainage into rock-filled infiltration trenches with no piped drainage (other than overflows from rock trenches). All site furnishings made of recycled plastic and recycled aluminum. Pervious pavement with storm water storage/infiltration in base - in Phase 1. Constructed/directed public access points to beach and overlooks. Pumpable vault toilets with demand lighting. No landscape or street lighting in the park - zero light trespass. Removal and ongoing monitoring/management of exotic invasive plants. Developed facilities are barrier free (parking, main paths, overlooks, boardwalks, benches, some picnic tables).
